Consolidated Version – Occupational Accidents

OCCUPATIONAL ACCIDENT (III 5)

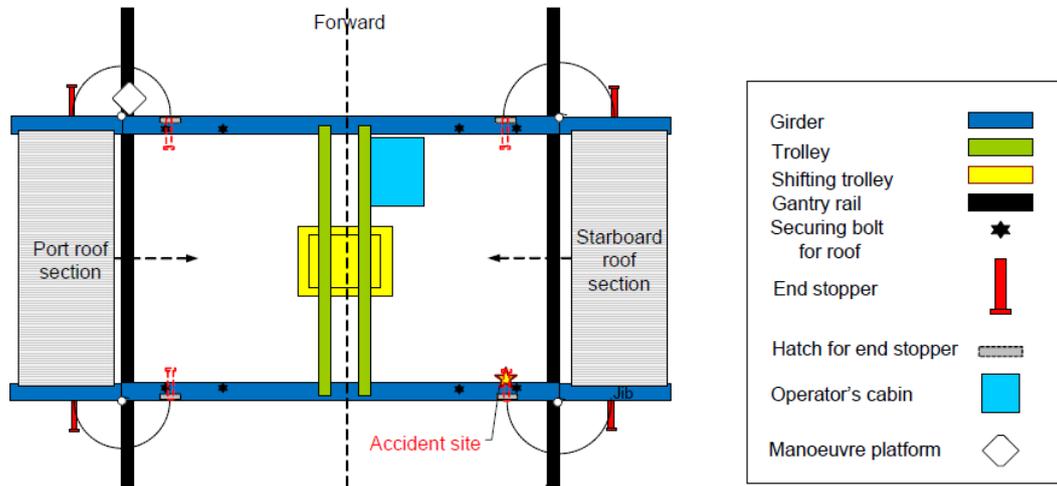
Figure 1: Simplified drawing of the gantry crane seen from above.

Swinging in of the jibs is done from a manoeuvring panel on a platform below the crane's forward port leg. A third crewmember went to the manoeuvring platform to swing in the jibs.

After confirmation that all crew were in a safe position, the four jibs were set in motion. Subsequently, and without notifying the other crew involved, two crew members on the girders of the gantry crane identified that the end stopper hatches located in the protective walls needed to be open. The two crew then immediately went and opened the end stopper hatches. Following that, one crewmember was found struck and killed by the end stop of the starboard aft jib.
