Consolidated version Collisions Contacts

COLLISION (III 5)

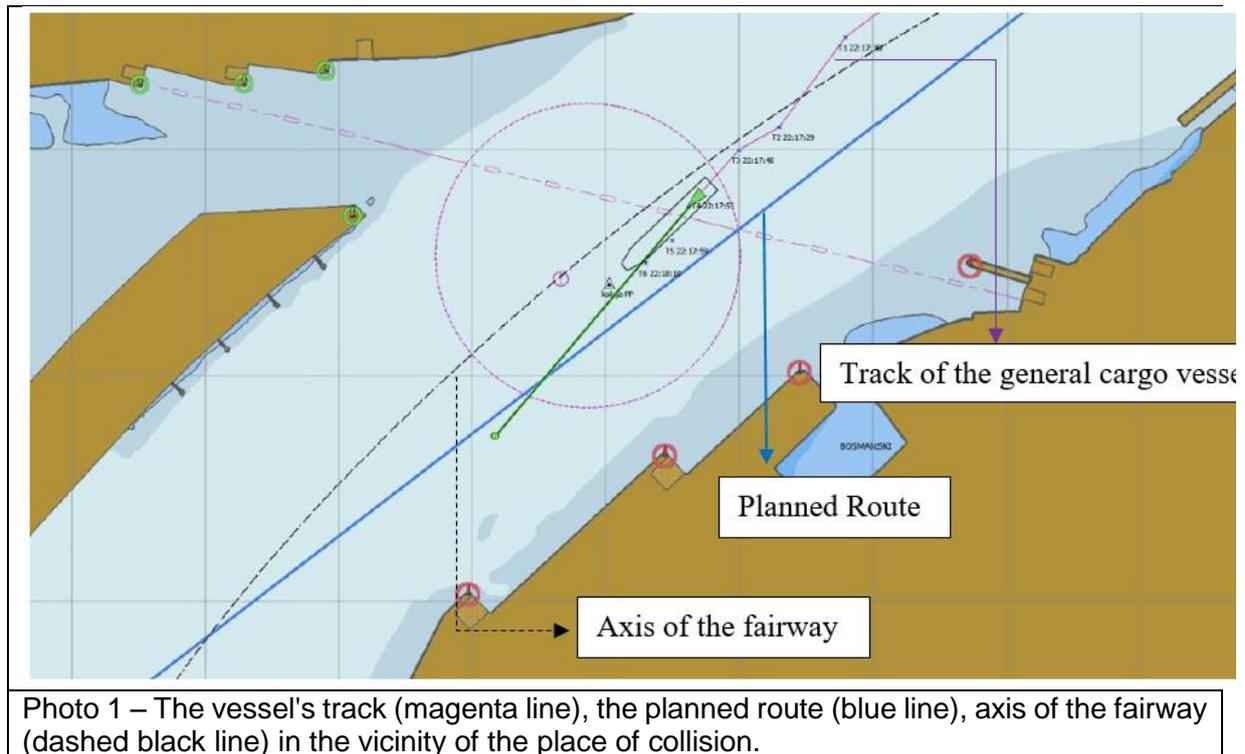
The general cargo vessel was manned only by the master who had not arranged for a proper lookout. Its radar had detected the echo of the tug boat on the starboard side at a distance of about 8 cables, but no action had been taken to determine the passing manoeuvres or to move to starboard to the outer limit of the fairway.

The master had altered his vessel's course following the planned course as laid in his electronic chart, unknowingly positioning his vessel at the wrong side of the fairway.

The pilot, during the transit in the fairway, also did not intervene when the general cargo vessel's course was altered to port so as to navigate the vessel on the wrong side of the fairway.
